**Office of Oversight
Environment, Safety and Health**

*Independent Investigation
of the*

Portsmouth Gaseous Diffusion Plant

*Volume 1: Past Environment,
Safety, and Health Practices*

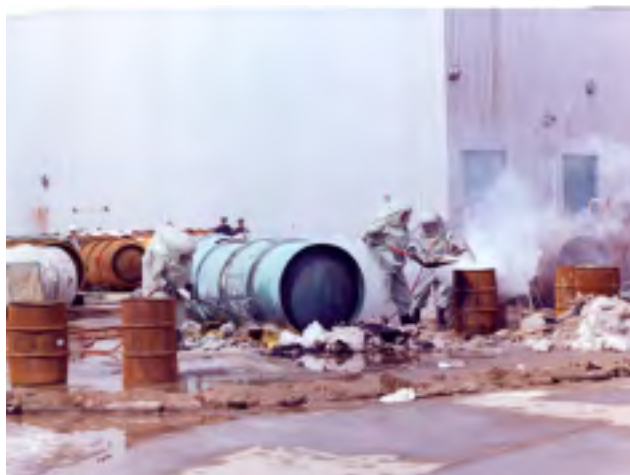
Cleanup of March 1978 Cylinder Drop

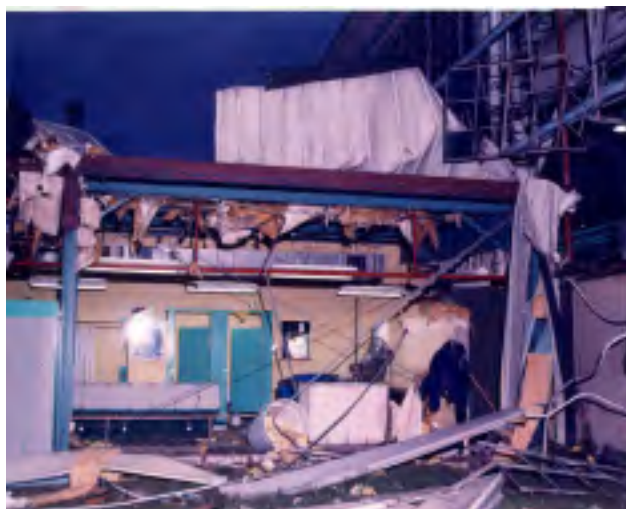
Converter Accident

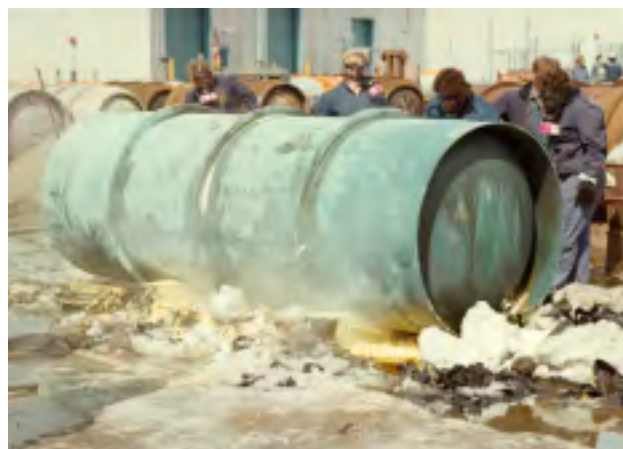
Cylinder Rupture
